SAMPLE INSPECTION REPORT

PROJECT: FLAT ROOF SOLUTION

ROOFING SYSTEM: HIGH ROOF: Inspection & Recommendations.

DATE: April 27, 2019

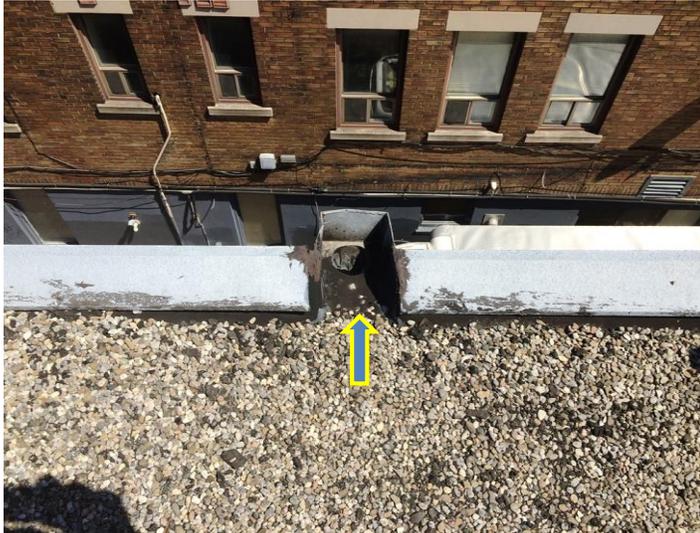
HIGH ROOF

INSPECTION NOTES: Core Existing Roof: (To be done with on owners consent)
1. Scupper Drains: a. Qty-2 x 6", Asphalt tie-ins are Cracked/Alligating & Splitting.
 b. Recommend installing one additional scupper.
2. Cones, Pipes & Goose Necks: Seals have dried out & cracked or completely deteriorated.

Qty-2 x 6", Asphalt tie-ins are Cracked/Alligatoring & Splitting.

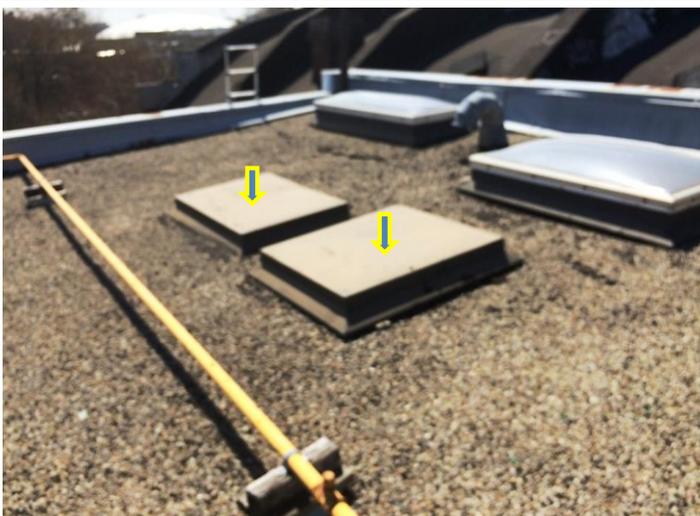
HIGH ROOF

3. Curbs & Parapet membrane flashings:
 a. 2 dorment curbs. Remove or if future need, Roof over?
 b. Membrane is Alligating / Dried, Cracked & Splitting

There are 2 dormer mechanical curbs.

Recommendations:

Option-1: If you are not adding any HVAC in the future.

- Remove & Restore roof deck before installing new roof system

Option-2: If you believe may have a future need.

- Leave them and roof them in.
- They can be cut open if & when required

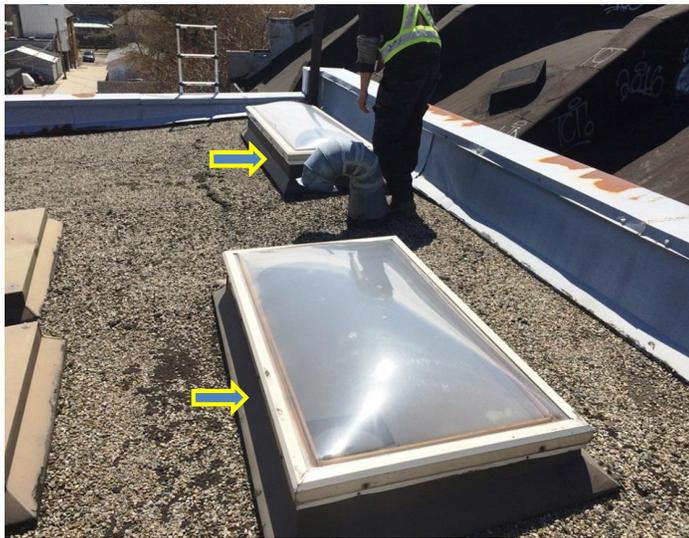
HIGH ROOF

Mechanical Curbs:

- Membrane is Alligating / Dried, Cracked & Splitting
[Note: "Alligating: a result of the drying out and shrinking of the asphalt surface resulting in a "mud-cracking" pattern. If left untreated, the alligating condition can develop into membrane splits. These crack channels will allow water to penetrate roof and possibly damage the building interior.]

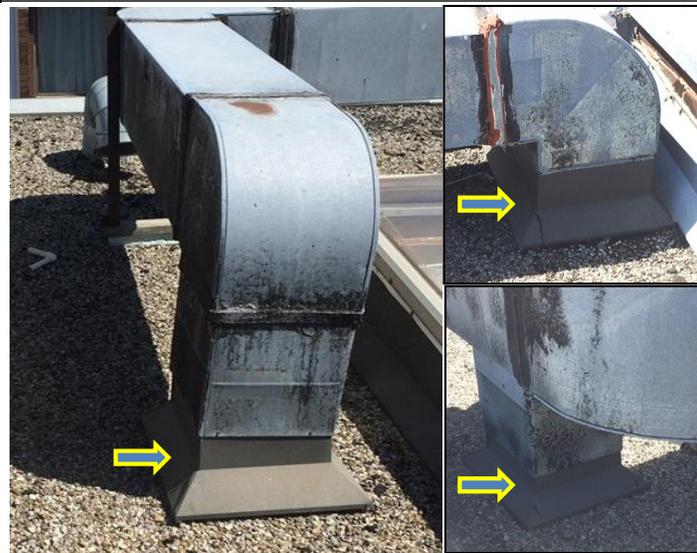
HIGH ROOF

Mechanical Curbs:

- Are Alligating / Dried, Cracked & Splitting
[Note: "Alligating: a result of the drying out and shrinking of the asphalt surface resulting in a "mud-cracking" pattern. If left untreated, the alligating condition can develop into membrane splits. These crack channels will allow water to penetrate roof and possibly damage the building interior.]

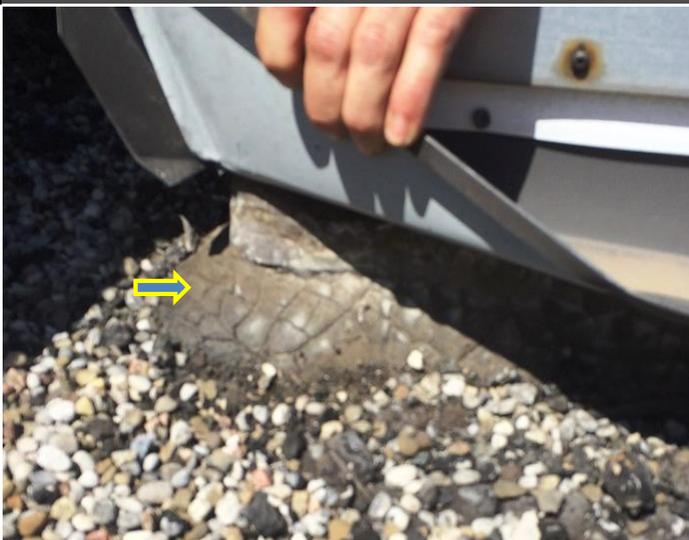
HIGH ROOF

Mechanical Curbs:

- Are Alligating / Dried, Cracked & Splitting
[Note: "Alligating: a result of the drying out and shrinking of the asphalt surface resulting in a "mud-cracking" pattern. If left untreated, the alligating condition can develop into membrane splits. These crack channels will allow water to penetrate roof and possibly damage the building interior.]

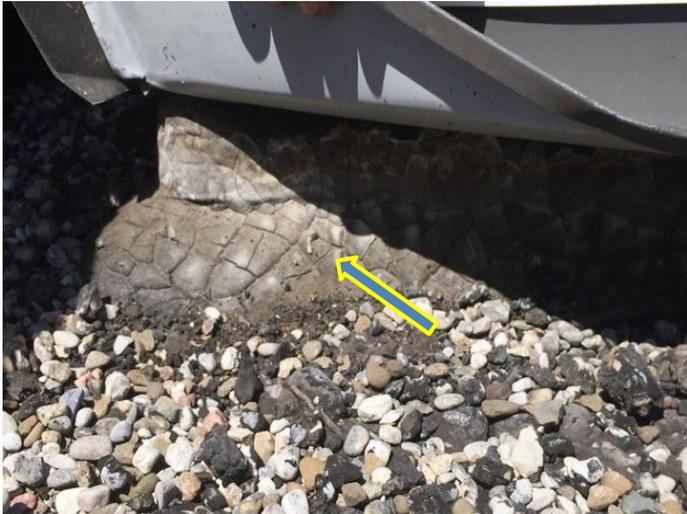
HIGH ROOF

Mechanical Curbs:

- Are Alligating / Dried, Cracked & Splitting

[Note: "Alligating: a result of the drying out and shrinking of the asphalt surface resulting in a "mud-cracking" pattern. If left untreated, the alligating condition can develop into membrane splits. These crack channels will allow water to penetrate roof and possibly damage the building interior."

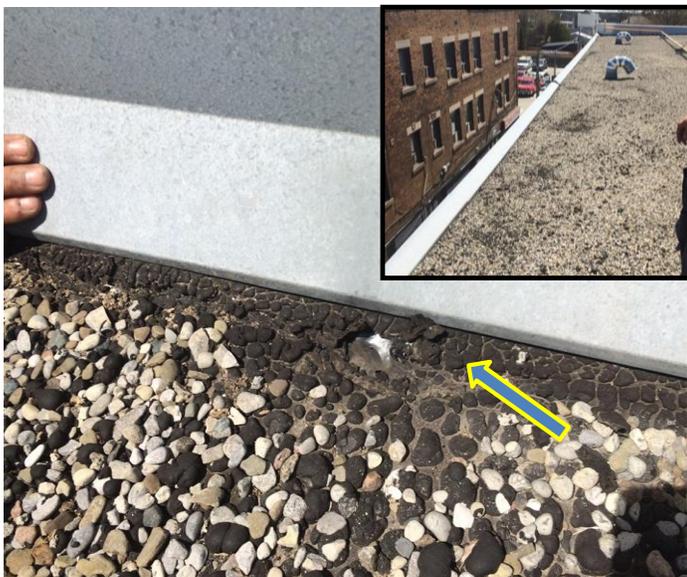
HIGH ROOF

Parapet wall membrane flashings:

- Are Alligating / Dried, Cracked & Splitting

[Note: "Alligating: a result of the drying out and shrinking of the asphalt surface resulting in a "mud-cracking" pattern. If left untreated, the alligating condition can develop into membrane splits. These crack channels will allow water to penetrate roof and possibly damage the building interior."

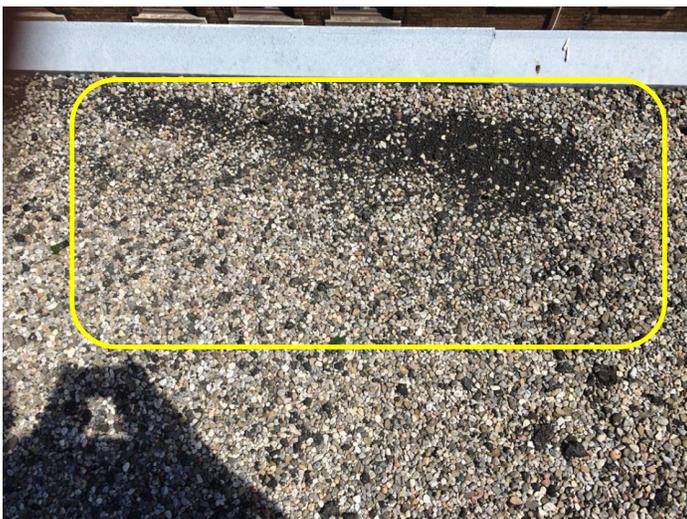
HIGH ROOF

Field (Flat Areas):

- Alot of Blueberries noted:

"Blueberries: The result of dried out asphalt. They appear on the roof as small blue or black balls, When the top pour of asphalt erodes to this stage, the roof system has lost at least 40% of its waterproofing ability."

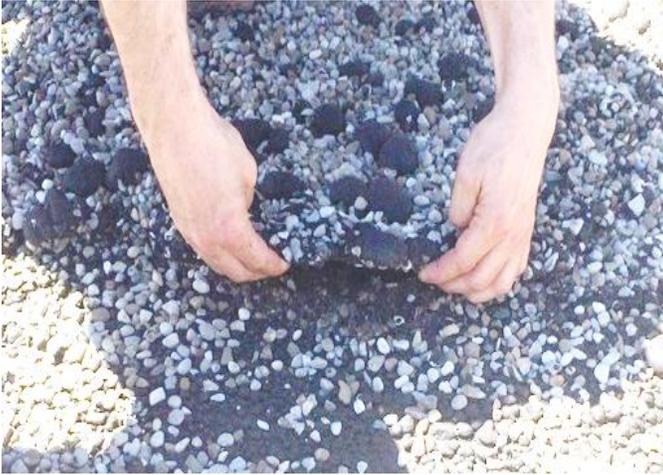
HIGH ROOF

Field (Flat Areas):

Asphalt in Roof system has lost most of it's bonding strength and the plys are separating.

The separation will allow water to penetrate & deteriorate the remaining plys below.

When all plys have deteriorated or cracked, water will penetrate the interior of the building & cause damage.

A number of areas have already lost 1 or 2 plys.

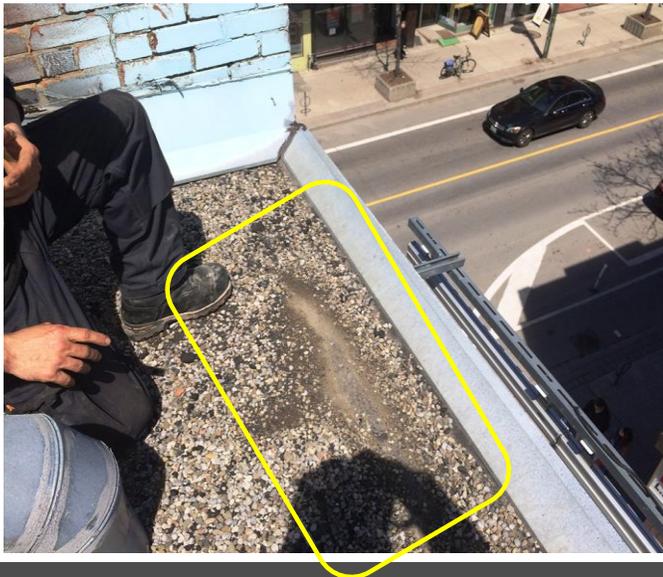
HIGH ROOF

Field (Flat Areas):

- This is whats referred to as a blister

"Blisters: soft spongy pockets or swellings in the roof membrane. They occur between layers of felt or between the roof membrane and substrate. Air or moisture vapour entrapped within a blister expands exponentially as the roof and outside air temperatures rise. This results in sufficient pressure to push the felts upwards and split open. Blisters may be ruptured by roof traffic, expanding frozen water, or hail (especially during colder weather). Some blisters may become so large as to affect drainage and cause pounding water. Seams may split apart, resulting in leakage. A ruptured blister will immediately allow water to penetrate the roof and possibly damage the building interior."

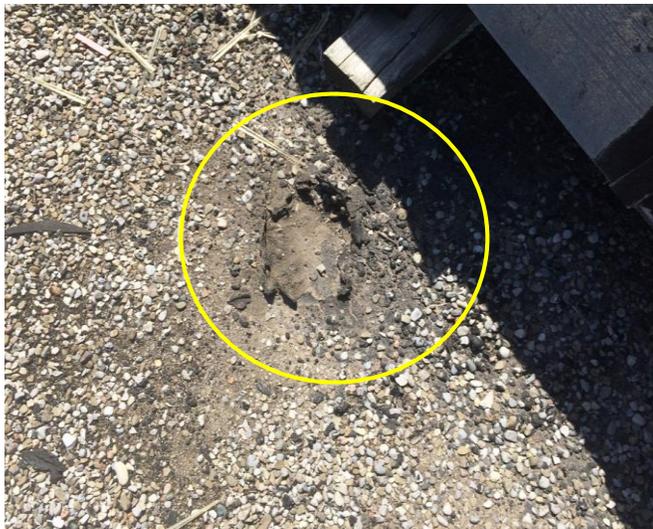
HIGH ROOF

Field (Flat Areas):

Asphalt in Roof system has lost most of it's bonding strength and the plys are separating.

The separation will allow water to penetrate & deteriorate the

When all plys have deteriorated or cracked, water will penetrate the interior of the building & cause damage.

A number of areas have already lost 1 or 2 plys.

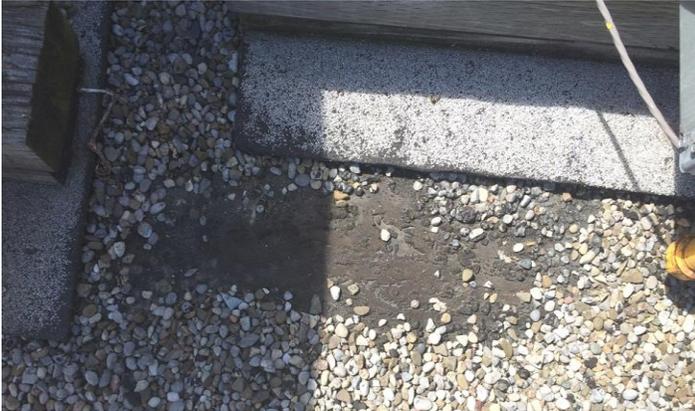
HIGH ROOF

Field (Flat Areas):

Asphalt in Roof system has lost most of its bonding strength and the plys are separating.

The separation will allow water to penetrate & deteriorate the remaining plys below.

When all plys have deteriorated or cracked, water will penetrate the interior of the building & cause damage.

A number of areas have already lost 1 or 2 plys.

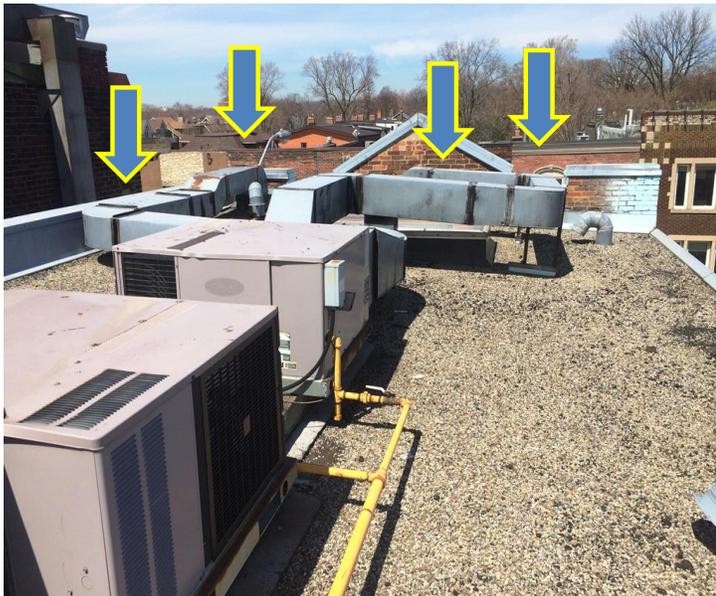
HIGH ROOF

Roof top Mechanical assemblies (HVAC & Ducts)

a. Many of the units are old & rusted.

b. The seal on Ductwork joints is old & poorly applied

Experience has shown that old HVAC assemblies;

- 1.) Rust right through in some areas allowing water through to penetrate & damage the building interior.
- 2.) Internal drains clog & overflow, allowing water to enter the duct work, penetrate & damage the building interior.
- 3.) Ducts & duct joints are common leak sources

Solution:

Insulate and wrap all ducts & joints with a PVC membrane.

Recommendation:

After new roof is installed preform a water test .

Test the entire roof & HVAC assemblies

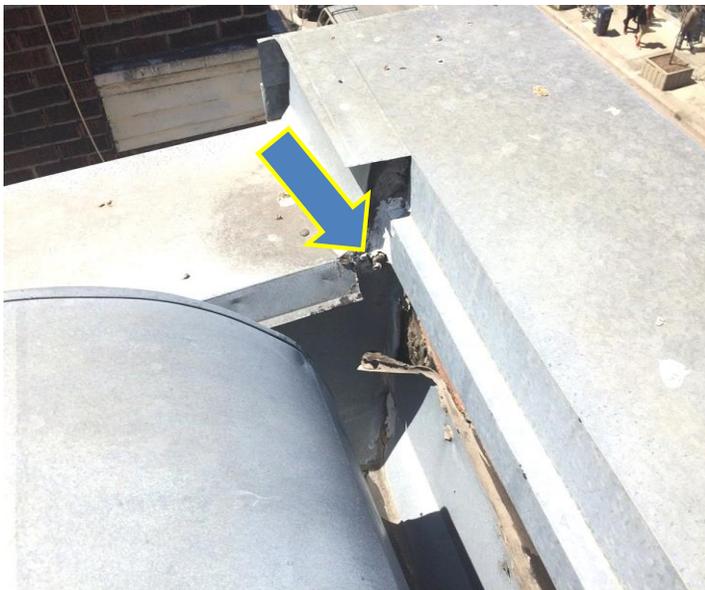
HIGH ROOF

Wall Terminations are failing.

Water can go behind the metal & penetrate the interior of the building & cause damage.

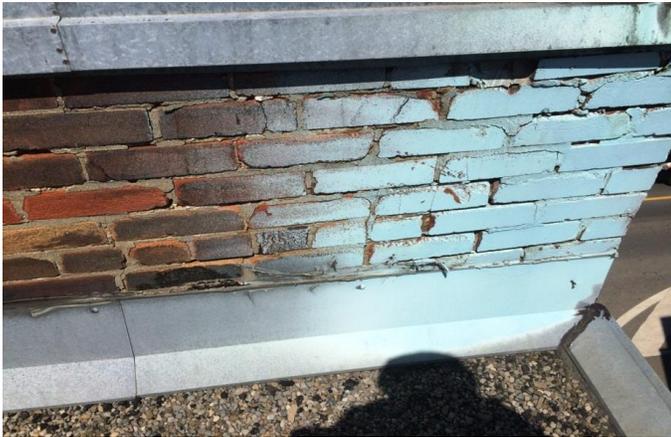
HIGH ROOF

Wall structure: Is Weak

Many area, parapet walls are deteriorated and missing mortar.

Solution: They should be;

Option-1: Either tuck pointed or rebuild

Option-2: Covered with plywood and roofed in.

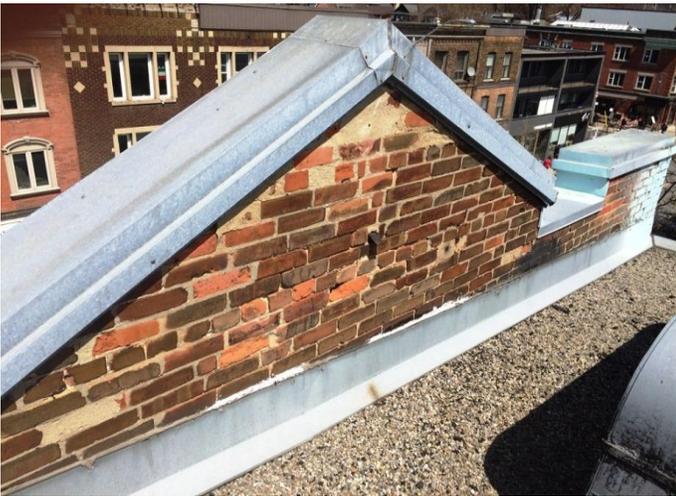
HIGH ROOF

Wall structure: Is Weak

Many area, parapet walls are deteriorated and missing mortar.

Solution: They should be;

Option-1: Either tuck pointed or rebuild

Option-2: Covered with plywood and roofed in.

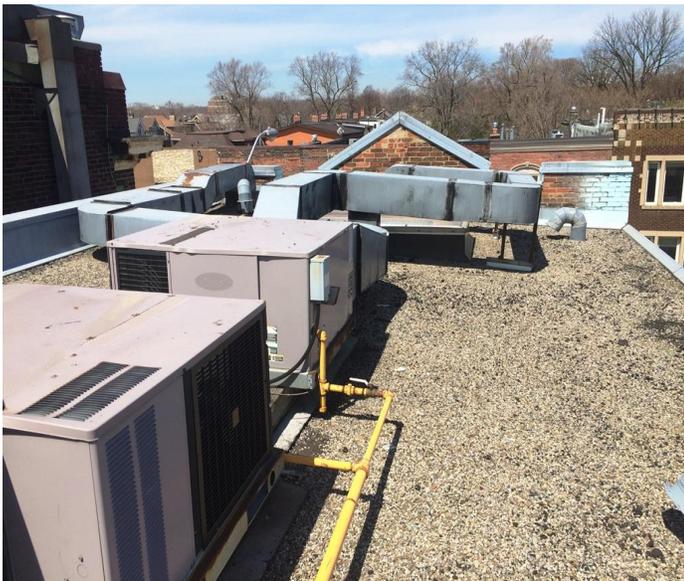
HIGH ROOF

Conclusion:

I would estimate the age of this roof to be between 30-40 yrs. Industry Experts & Manufacturers list it's life expectancy at 20-25

This roof has surpassed industry standards because of it's slope.

Water has not been able to pond on & deteriorate this roof.

Is this roof was a truly flat roof, your leaks would have been much more savour, as would your interior damages.

Attempting to repair this roof would be a very poor investment as repairs would be very expensive & very short lived.

A repair is only as strong as the existing membrane you are adhering to.
