## SAMPLE INSPECTION REPORT

**PROJECT:** FLAT ROOF INSPECTION

**ROOF SYSTEM:** SAMPLE 4-PLY INSPECTION REPORT

**DATE:** May 17, 2019

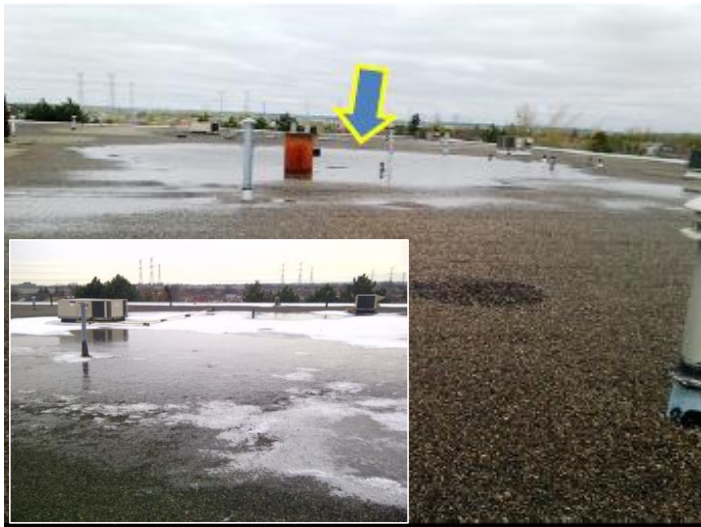
**Ponding water collects in large pools on the roof surface.**

**Two reasons: ,**

- (1) roof drains are blocked or clogged with debris
- (2) roof drains are attached to support columns which maintain a consistent height while the rest of the roof system is built on a deck which tends to move and sag or sink

Small cracks and tears will widen until they rupture to allow water into the building causing interior damage.

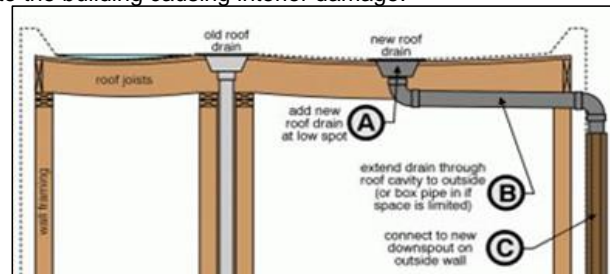
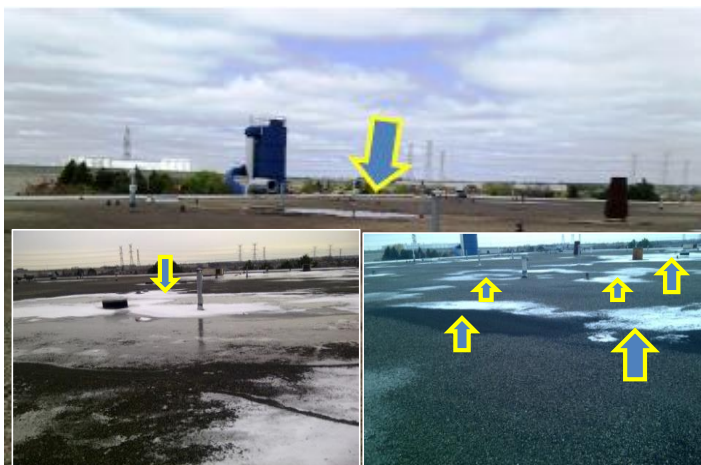
**Ponding water collects in large pools on the roof surface.**

**Two reasons: ,**

- (1) roof drains are blocked or clogged with debris
- (2) roof drains are attached to support columns which maintain a consistent height while the rest of the roof system is built on a deck which tends to move and sag or sink under the weight of the roof system, mechanical units and pools of water.

In both cases, roof depressions that collect and hold water will tend to grow in size as the added weight of the pooling water will continue to cause exponential sagging of the roof deck. Ponding water has many negative effects on a roof system. The weight can crush insulation rendering it a useless thermal barrier - this will cost you big money since your HVAC system will have to work longer and harder to maintain a comfortable interior temperature. In the winter ponding water will expand as it freezes. This expansion will weaken imperfections in the roof system.

Small cracks and tears will widen until they rupture to allow water into the building causing interior damage.

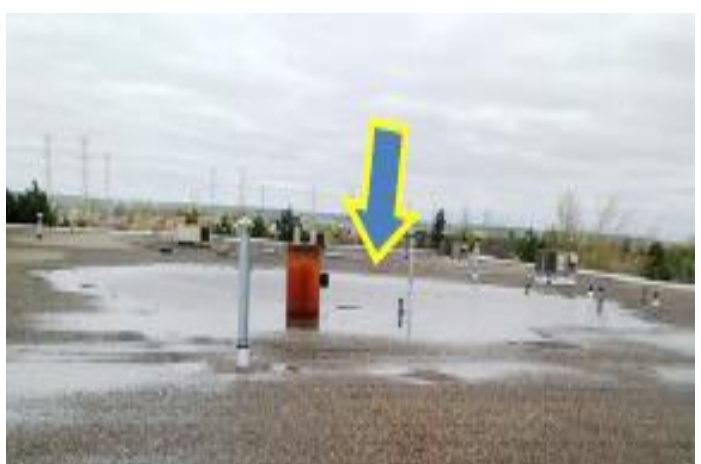
**Ponding water collects for 2 reasons: ,**

- (1) roof drains are blocked or clogged with debris
- (2) roof drains are attached to support columns which maintain a consistent height while the rest of the roof system is built on a deck which tends to move and sag or sink under the weight of the roof system, mechanical units and pools of water.

In both cases, roof depressions that collect and hold water will tend to grow in size as the added weight of the pooling water will continue to cause exponential sagging of the roof deck. Ponding has many negative effects on a roof system. The weight can crush insulation rendering it a useless thermal barrier - this will cost you big money since your HVAC system will have to work longer and harder to maintain a comfortable interior temperature. In the winter ponding water will expand as it freezes. This expansion will weaken imperfections in the roof system.

Small cracks and tears will widen until they rupture to allow water into the building causing interior damage.

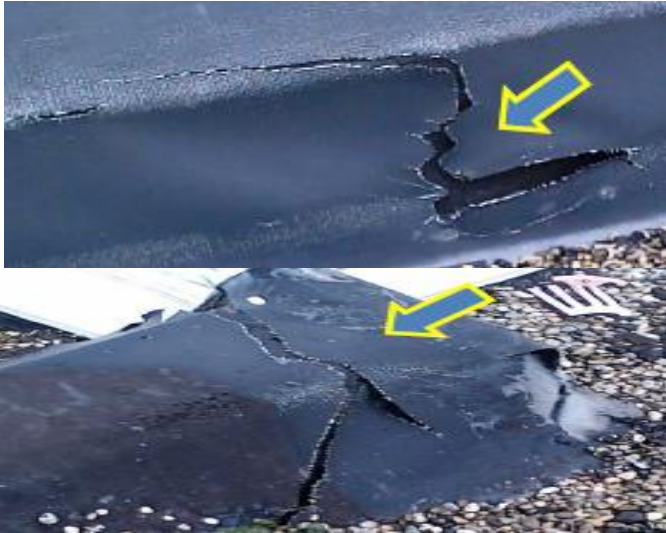
**EXPANSION MEMEBRANE FLASHING**

Membrane is dry out and split open

Water has & will continue to enter the building  
causing interior damage.

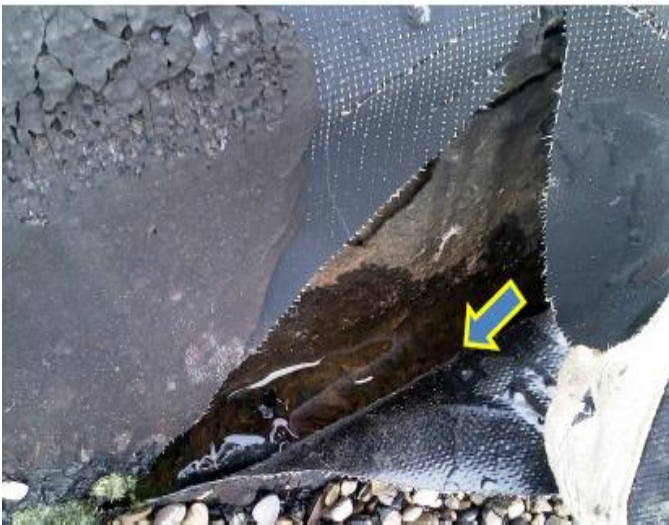
**EXPANSION MEMEBRANE FLASHING**

Membrane is dry out and split open

Water has & will continue to enter the building  
causing interior damage.

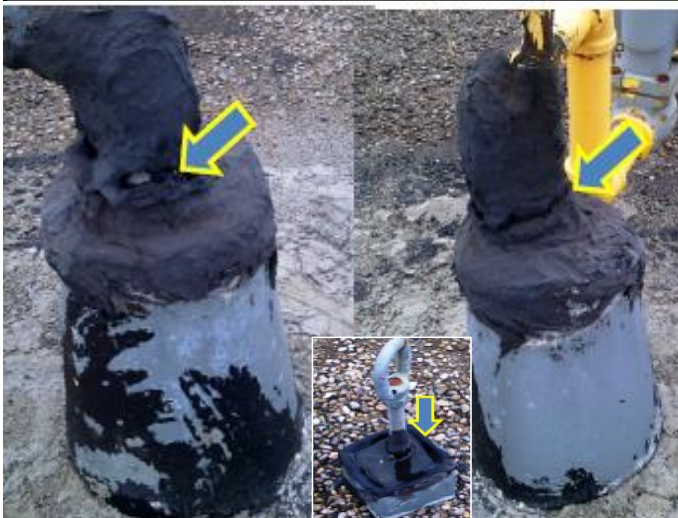
**PITCH POCKET FLASHING / SEALANT**

Sealant is dry out and split open

Water has & will continue to enter the building  
causing interior damage.

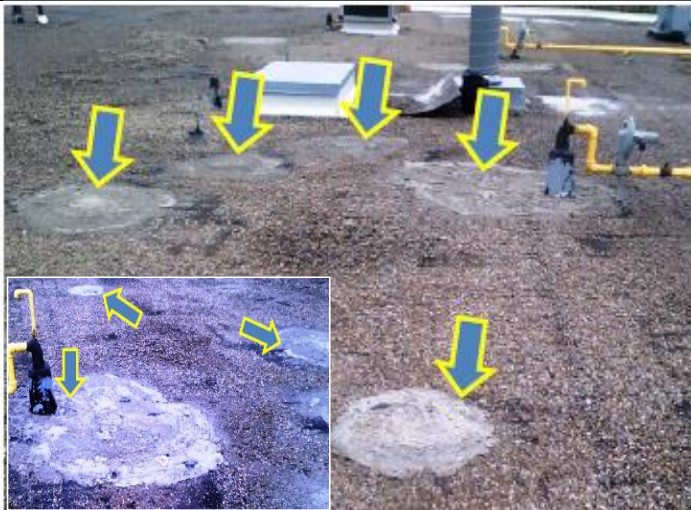
**Tempoary stop leak cement used during rain**

Cement will break down within;

- 1. In the summer 2 to 6 months
- 2. In the winter 1 or 2 freeze-thaw cycles.

When cement breaks down, water will enter the building causing interior damage.

On a dry day (Membrane must be dry);

- a) Cement should be removed
- b) A perminant patch installed

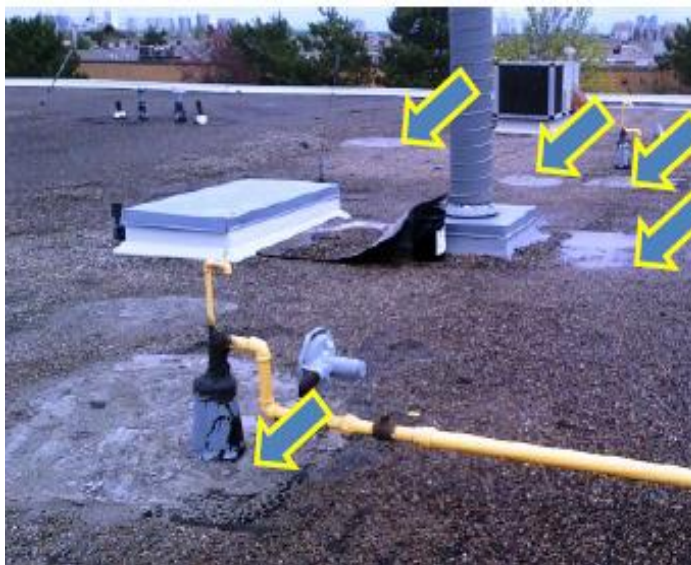
More tempoary stop leak cement used and never patched

Cement will break down within;

- 1. In the summer 2 to 6 months
- 2. In the winter 1 or 2 freeze-thaw cycles.

When cement breaks down, water will enter the building causing interior damage.

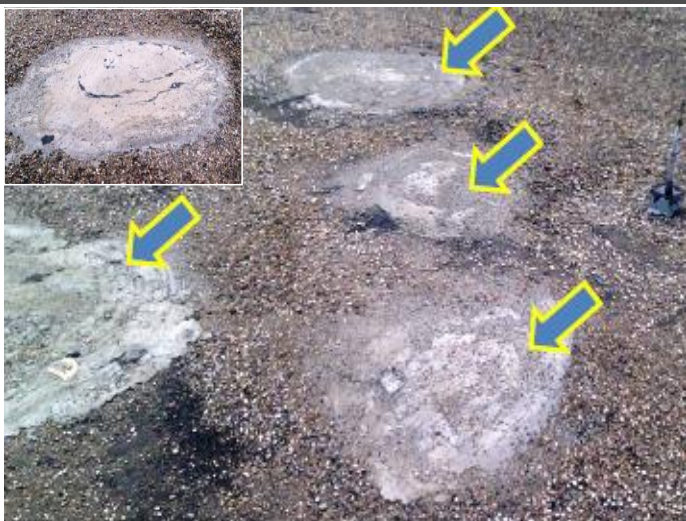
More tempoary stop leak cement used and never patched

Cement will break down within;

- 1. In the summer 2 to 6 months
- 2. In the winter 1 or 2 freeze-thaw cycles.

When cement breaks down, water will enter the building causing interior damage.

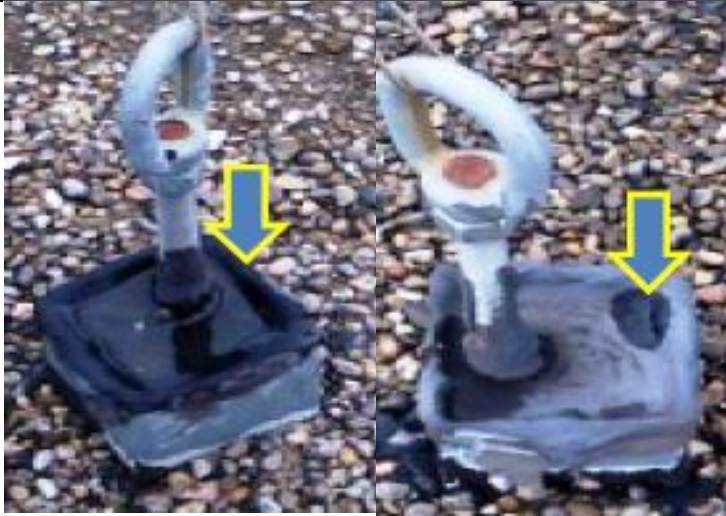
**PITCH POCKET FLASHING / SEALANT**

Sealant is dry out and split open

***Water has & will continue to enter the building causing interior damage.***

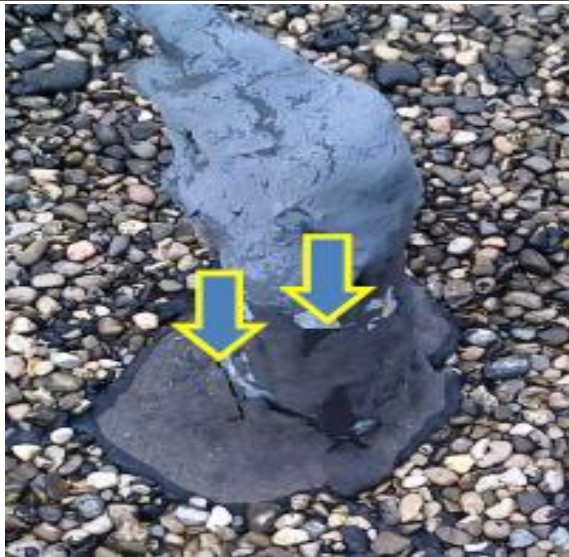
**PITCH POCKET FLASHING / SEALANT**

Sealant is dry out and split open

***Water has & will continue to enter the building causing interior damage.***

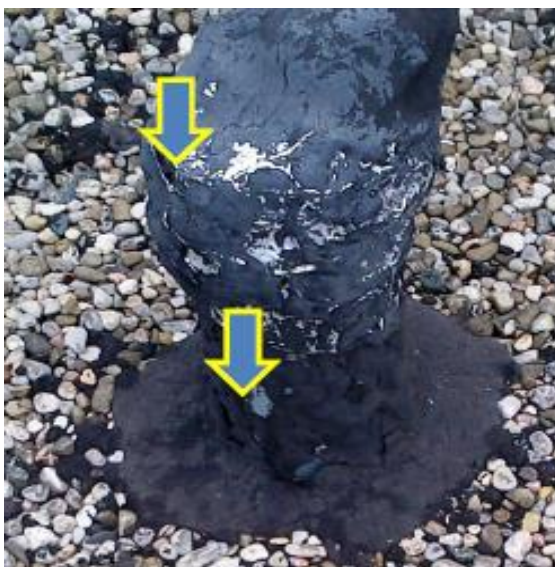
**PITCH POCKET FLASHING / SEALANT**

Sealant is dry out and split open

***Water has & will continue to enter the building causing interior damage.***

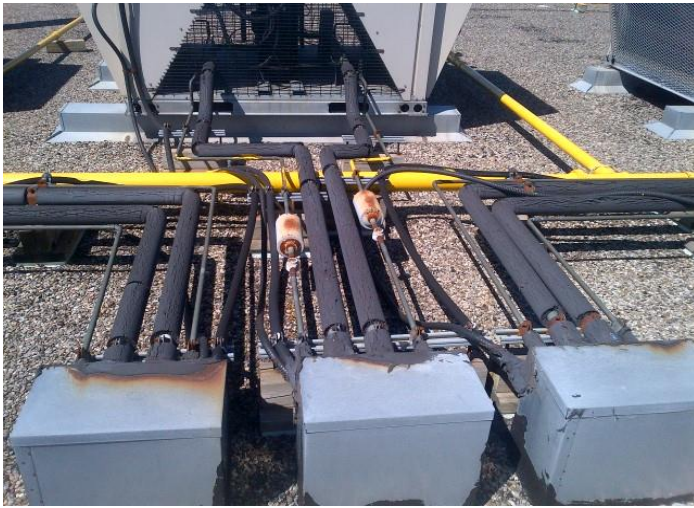
### FLASHING / SEALANT

Sealant is dry out and split open

***Water has & will continue to enter the building  
causing interior damage.***

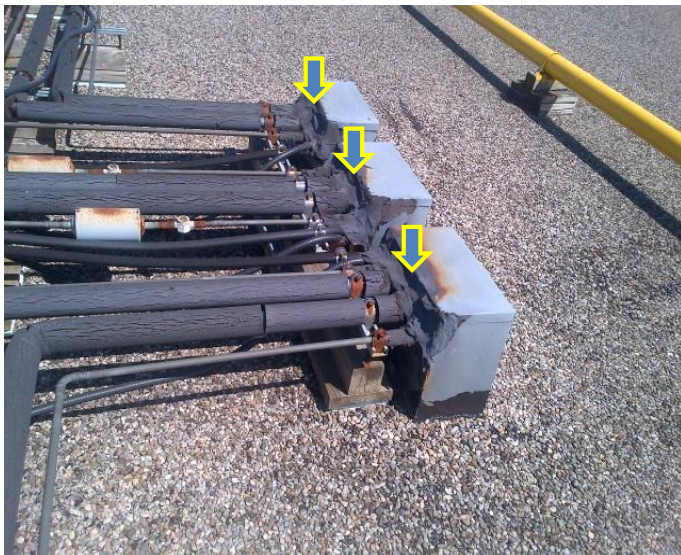
### FLASHING / SEALANT

Sealant is dry out and split open

***Water has & will continue to enter the building  
causing interior damage.***

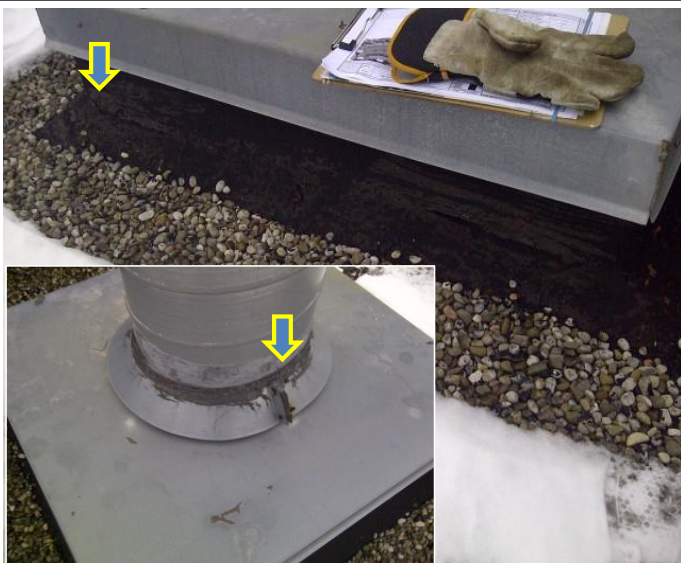
### CURB & PIPE FLASHING / MEMBRANE & SEALANT

Flashing is dry out and split open

***Water has & will continue to enter the building  
causing interior damage.***
