SAMPLE INSPECTION REPORT

PROJECT: FLAT ROOF SOLUTION

ROOFING SYSTEM: HIGH ROOF: Inspection & Recommendations.

DATE: April 27, 2019

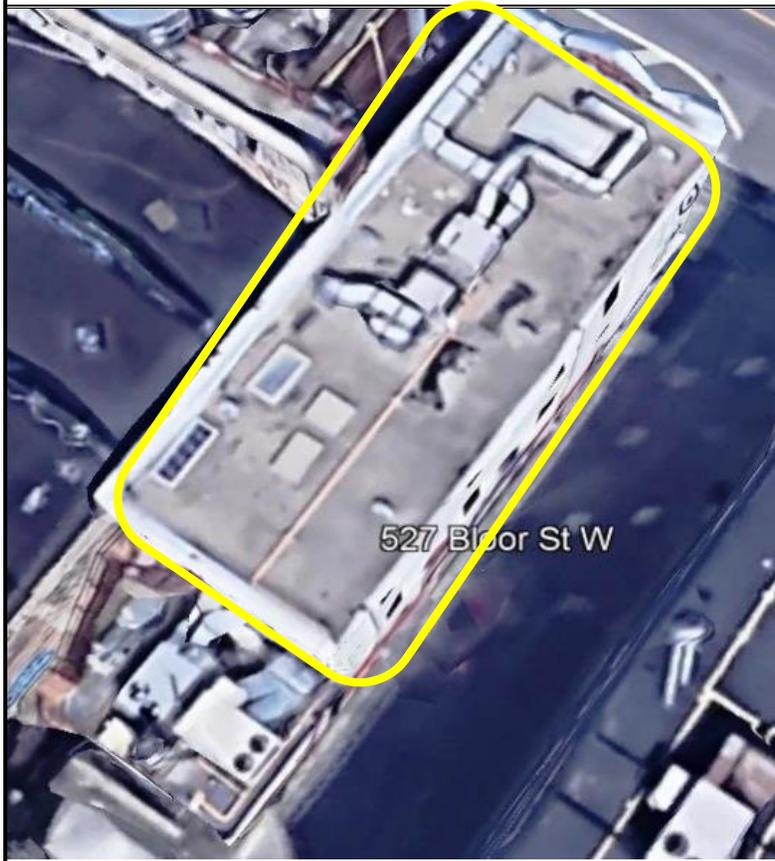
INSPECTION NOTES: Core Existing Roof: (To be done with on owners consent)
1. Scupper Drains: a. Qty-2 x 6", Asphalt tie-ins are Cracked/Alligating & Splitting.
 b. Recommend installing one additional scupper.
2. Cones, Pipes & Goose Necks: Seals have dried out & cracked or completely deteriorated.

3. Curbs & Parapet membrane flashings:
 a. 2 dorment curbs. Remove or if future need, Roof over?
 b. Membrane is Alligating / Dried, Cracked & Splitting

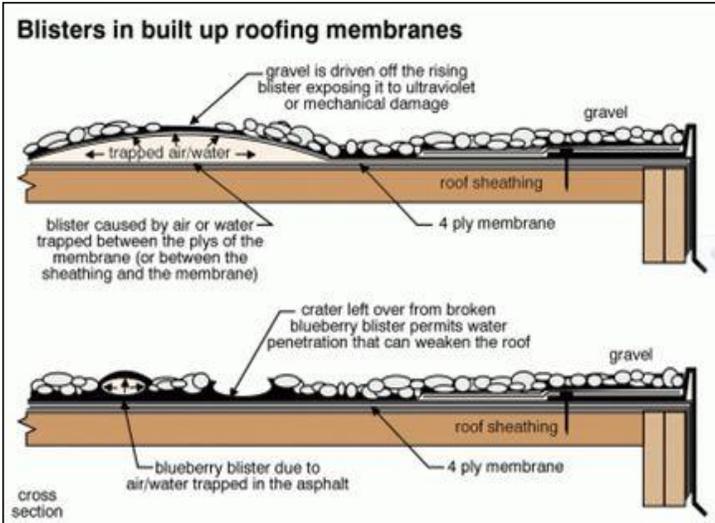
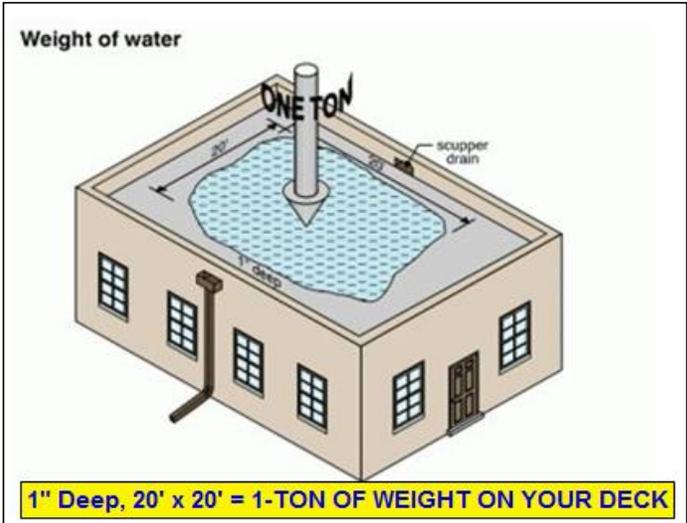
MOST COMMON PROBLEMS WITH AGING FLAT ROOFS

Common Faults that develop as Traditional Built Up Roofs (i.e. TAR & GRAVEL & MODIFIED BITUMEN) age:
