## SAMPLE INSPECTION REPORT

**PROJECT:** FLAT ROOF INSPECTION

**ROOF SYSTEM:** SAMPLE 4-PLY INSPECTION REPORT

**DATE:** May 17, 2019

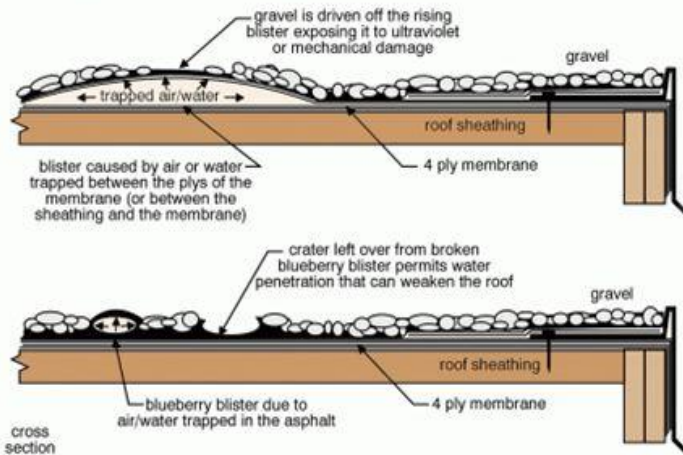
**Blisters in built up roofing membranes**

**Blisters:** soft spongy pockets or swellings in the roof membrane. They occur between layers of felt or between the roof membrane and substrate. Air or moisture vapour entrapped within a blister expands exponentially as the roof and outside air temperatures rise. This results in sufficient pressure to push the felts upwards and split open. Blisters may be ruptured by roof traffic, expanding frozen water, or hail (especially during colder weather). Some blisters may become so large as to affect drainage and cause pounding water. Seams may split apart, resulting in leakage. A ruptured blister will immediately allow water to penetrate the roof and possibly damage the building interior.

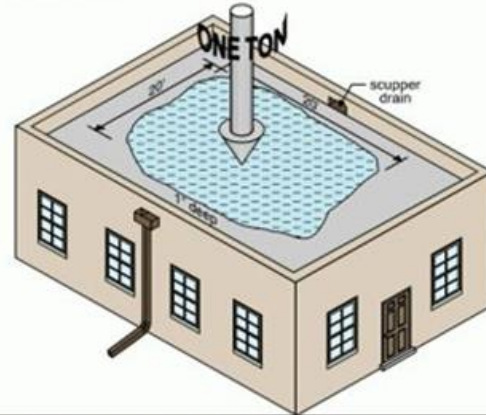
**Weight of water**

**1" Deep, 20' x 20' = 1-TON OF WEIGHT ON YOUR DECK**

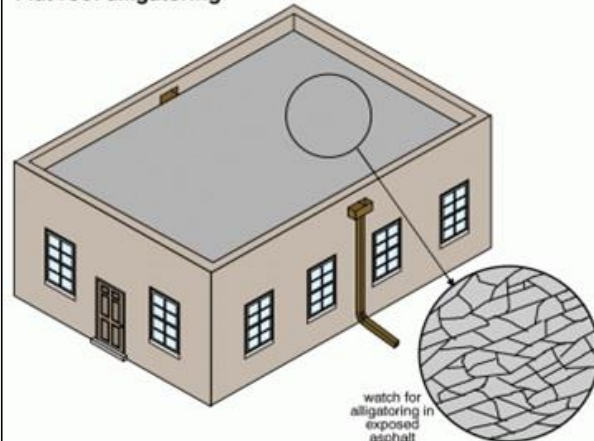
**Flat roof alligatoring**

**Alligatoring:** a result of the drying out and shrinking of the asphalt surface resulting in a “mud-cracking” pattern. The pattern is most pronounced in areas of exposed asphalt. It is caused by the heat and UV rays of the sun beating down. If left untreated, the alligatoring condition can develop into membrane splits. As the surface continues to shrink and dry out, cracks will develop and may stress-crack the membrane in cold weather. These crack channels will allow water to penetrate the roof and possibly damage the building interior.

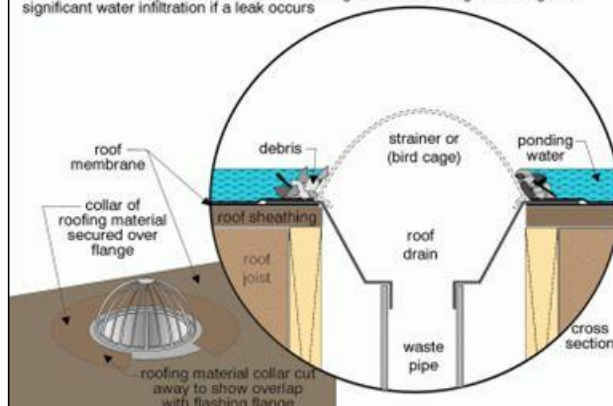
**Clogged interior flat roof drain**

interior flat roof drains clogged with debris can cause water ponding, leading to: shortened roof life, possible freeze/thaw damage, additional weight/roof sag and significant water infiltration if a leak occurs
